Army Lodging Wellness Recommendation

Fort Polk - Volume I

August 27, 2003

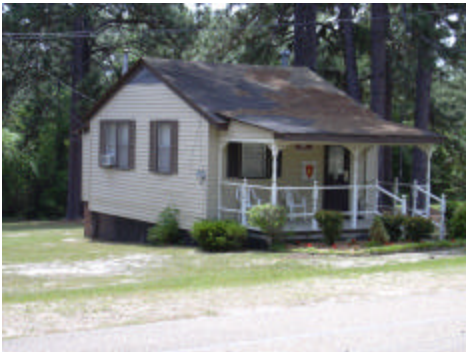
Lodging Buildings T-8, T-9, T-10, T-11, T-12, T-15, T-17, & T-18

These Lodging facilities, located in the area known as Traditions Circle, were constructed during World War II using wood frame construction techniques. Construction type, age, and condition of these facilities do not meet current Army Lodging standards. The cost to make condition assessment improvements to these facilities will exceed the 50% replacement cost.

Our recommendation is to remove buildings T-8, T-9, T-10, T-11, T-12, T-15, T-17, & T-18 from the Lodging inventory, allowing the installation to determine alternate uses for these facilities. These facilities will be removed from the Fort Polk Wellness Solution and Lodging Master Plan.

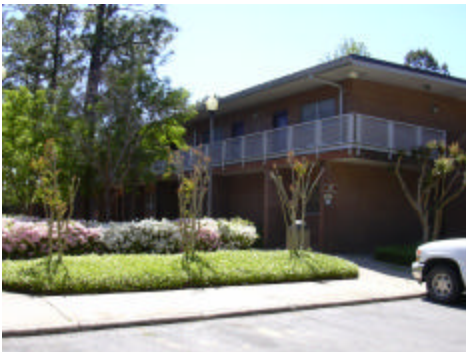
Lodging Buildings 331 & 332

Buildings 331 and 332, Cypress Inn, constructed in 1972, consist of 28 standard rooms and 32 extended stay rooms, respectively. Currently configured as exterior entrance rooms, these buildings are in poor condition. The cost to make condition assessment improvements will exceed the 50% replacement cost.

Our recommendation is to remove buildings 331 and 332 from the Lodging inventory, allowing the installation to determine alternate uses for these facilities. These facilities will be removed from the Fort Polk Wellness Solution and Lodging Master Plan.

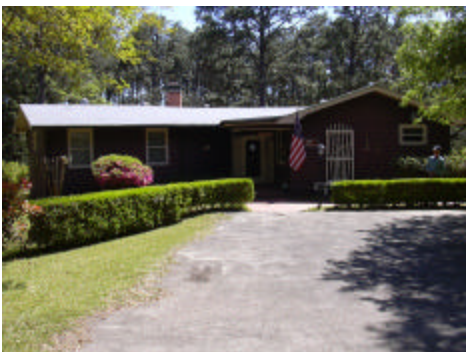
Lodging Building 426

Building 426, the Log Cabin, constructed in 1942, is an historic structure and home of the first Installation commander. Currently serving as VIP quarters for Fort Polk, the building consists of 3 bedrooms, a living room, kitchen, dining room, and den. This facility is in poor condition, and the cost to make condition assessment improvements will exceed the 50% replacement cost.

Our recommendation is to remove building 426 from the Lodging inventory, allowing the installation to determine an alternate use for the

facility. This facility will be removed from the Fort Polk Wellness Solution and Lodging Master Plan.

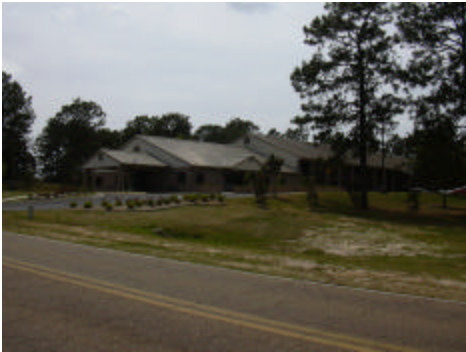
Lodging Building 522

Building 522, Magnolia House, constructed in 1988, consists of 70 extended stay rooms. This building currently serves as the primary check-in point for Lodging at Fort Polk and has recently undergone an extensive renovation to the lobby and administrative areas. The building, however, is missing a lot of the support spaces for a main Lodging facility, such as in-house laundry, storage, maintenance, conference rooms, and breakfast area. It is recommended to use this building a secondary facility and move all main Lodging support spaces to the new facility.

The Magnolia House is located in close proximity to several community facilities such as the Installation Exchange, Chapel, and Child Care Center. The rooms are currently configured as exterior entrance rooms.

To make condition assessment improvements and renovations to building 522 to meet current Lodging standards will not exceed the 50% replacement cost.

Our recommendation is to retain building 522 in the Fort Polk Lodging inventory, and to renovate to a secondary facility. This facility will remain in the Fort Polk Wellness Solution and Lodging Master Plan.

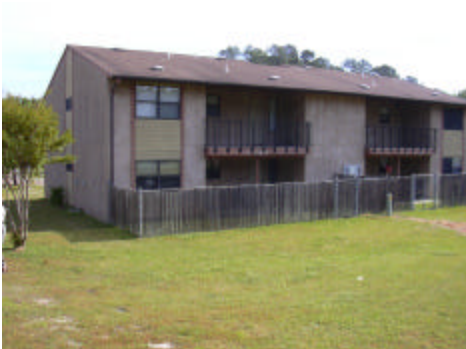
Lodging Buildings 5802-5830 (even numbers)

The 15 Lodging facilities located in the area known as Bradshaw Court were initially constructed as military family housing in 1982 and later converted to Lodging rooms. These facilities are in poor condition. To make condition assessment improvements will exceed the 50% replacement cost.

Our recommendation is to remove buildings 5802-5830 (even numbers) from the Lodging inventory, allowing the installation to determine alternate uses for these facilities. These facilities will be removed from the Fort Polk Wellness Solution and Lodging Master Plan.

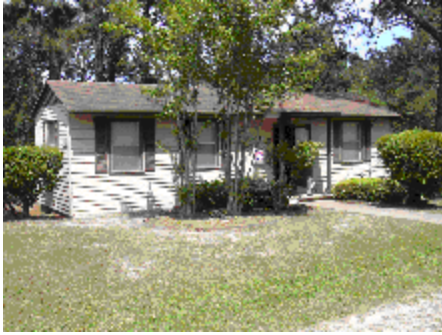
Building T-08 was constructed in 1941. The 883 square foot facility contains 1 lodging units, operating as a family suite for distinguished visitors.

Condition Assessment Cost	\$103,045.00
Replacement Cost	\$113,700.00
Condition Assessment to Replacement Cost Ratio	90.63%

Because the Condition Assessment to Replacement Cost Ratio is greater than 50%, renovation of Building T-08 is not recommended.

- Analysis: The foundation is a pier and beam construction with the concrete piers added at a later date. There is some evidence of minor settlement. A complete evaluation of the foundation system including recommendations and estimates for repair are beyond the scope of work for this project. A structural engineer should assess the foundation to determine the condition.
- Recommendation: Provide a structural engineer to evaluate the foundation and develop cost estimates for repairs.

- Analysis: The windows are single glazed aluminum in aluminum frames. The windows are beyond their useful life.
- Recommendation: Replace aluminum windows.
